ZONE 1: WYE ROAD ORDZE AREA

STREETSCAPE

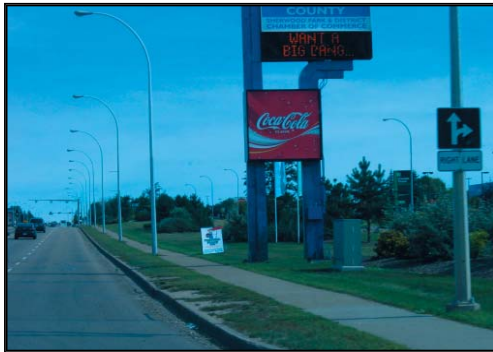
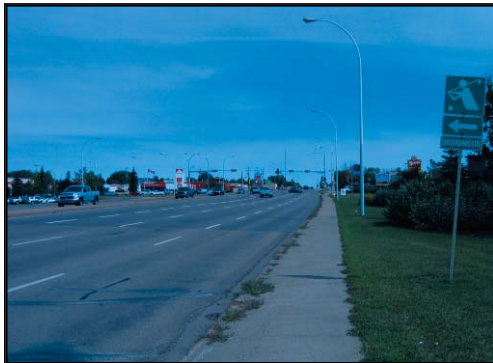
EXISTING CONDITIONS/ CONSTRAINTS

- Between Ordze Road and Sherwood Drive, an existing sidewalk on the south side of Wye Road offers pedestrians little in the way of comfort or safety. The existing sidewalk is located directly adjacent to the roadway making it both dangerous and noisy.
- Existing street signs are not organized.
- Straight sidewalk without any seating.

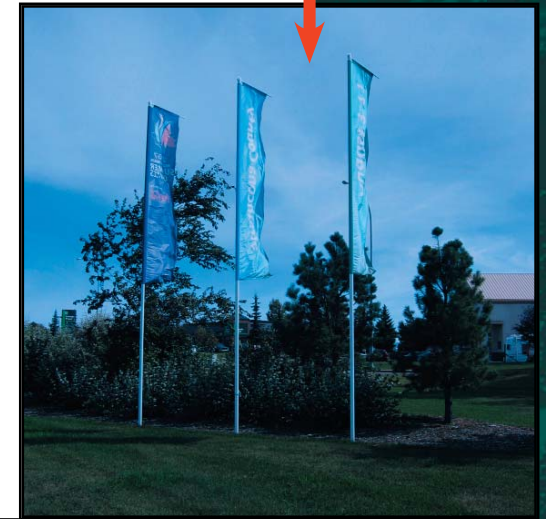
OPPORTUNITIES (EXAMPLE 1)

In the area where Ordze Road parallels Wye Road, an existing 16m wide greenway has the potential to offer a more pleasant pedestrian experience.

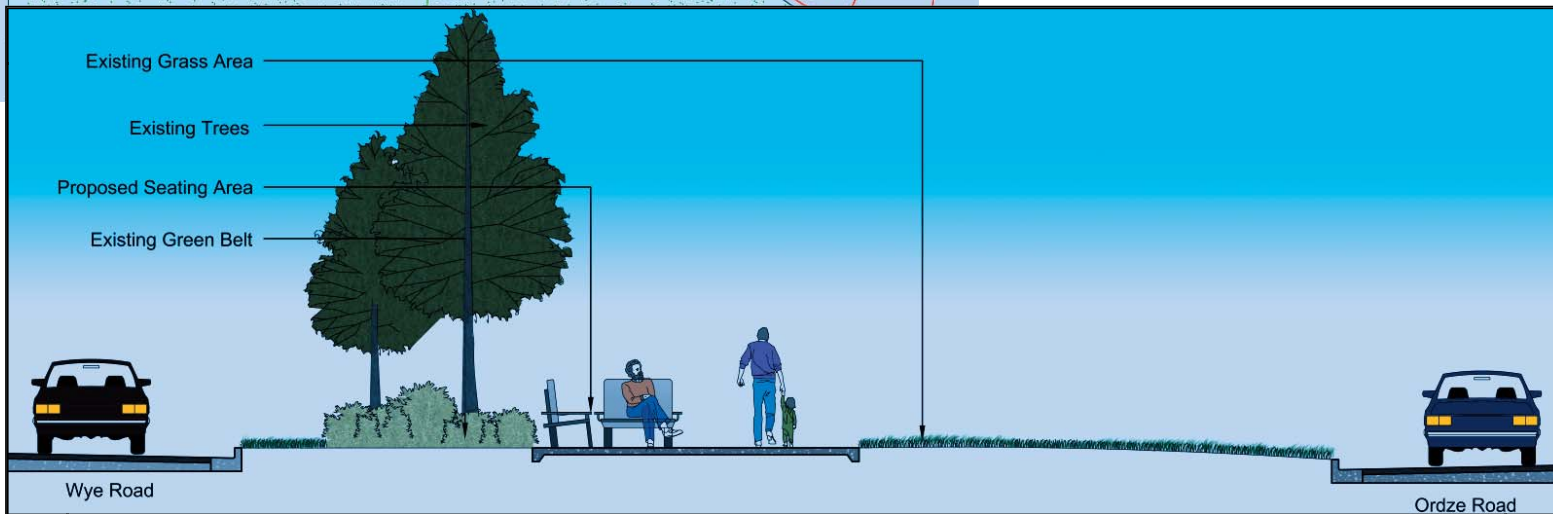
OPPORTUNITIES (EXAMPLE 4)
Shows that it is possible to provide opportunity for seating plazas where space is available.
